Manhole Inspection Summary

Manhole # S17K__005MH

Location Address: **2426 franklin-alley-catherine** Cross Street: **s catherine st**

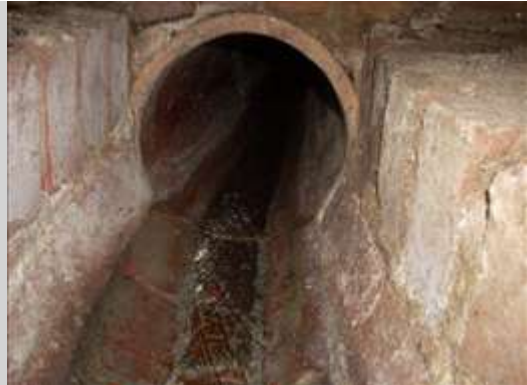
12 O'Clock Outflow

8 in. Circular Gravity Sewer
Pipe Out @ 12 O'Clock

Pipe Height: **7.2** (in.) Rod and Bar (Angled)
Pipe Material: **Clay** ☐ Pipe Lined
Invert Depth: **7.91** (ft.) Flow Characteristics: **Slow**
Deposits: ☒ None ☐ Mud ☐ Sludge ☐ Debris ☐ Grease
Silt Depth: **0** (in.) Deposits Extent:
Infiltration: **None** Pipe Seal Cond: **Sound**
